RE: **Preliminary Assessment for Arlon, Inc., Bear, Delaware**
RCRA Facility # DED980551261

**PRELIMINARY ASSESSMENT
FOR
ARLON, INC.
RCRA FACILITY # DED980551261
BEAR, DELAWARE**

**DNREC Project DE-289
March 1999**

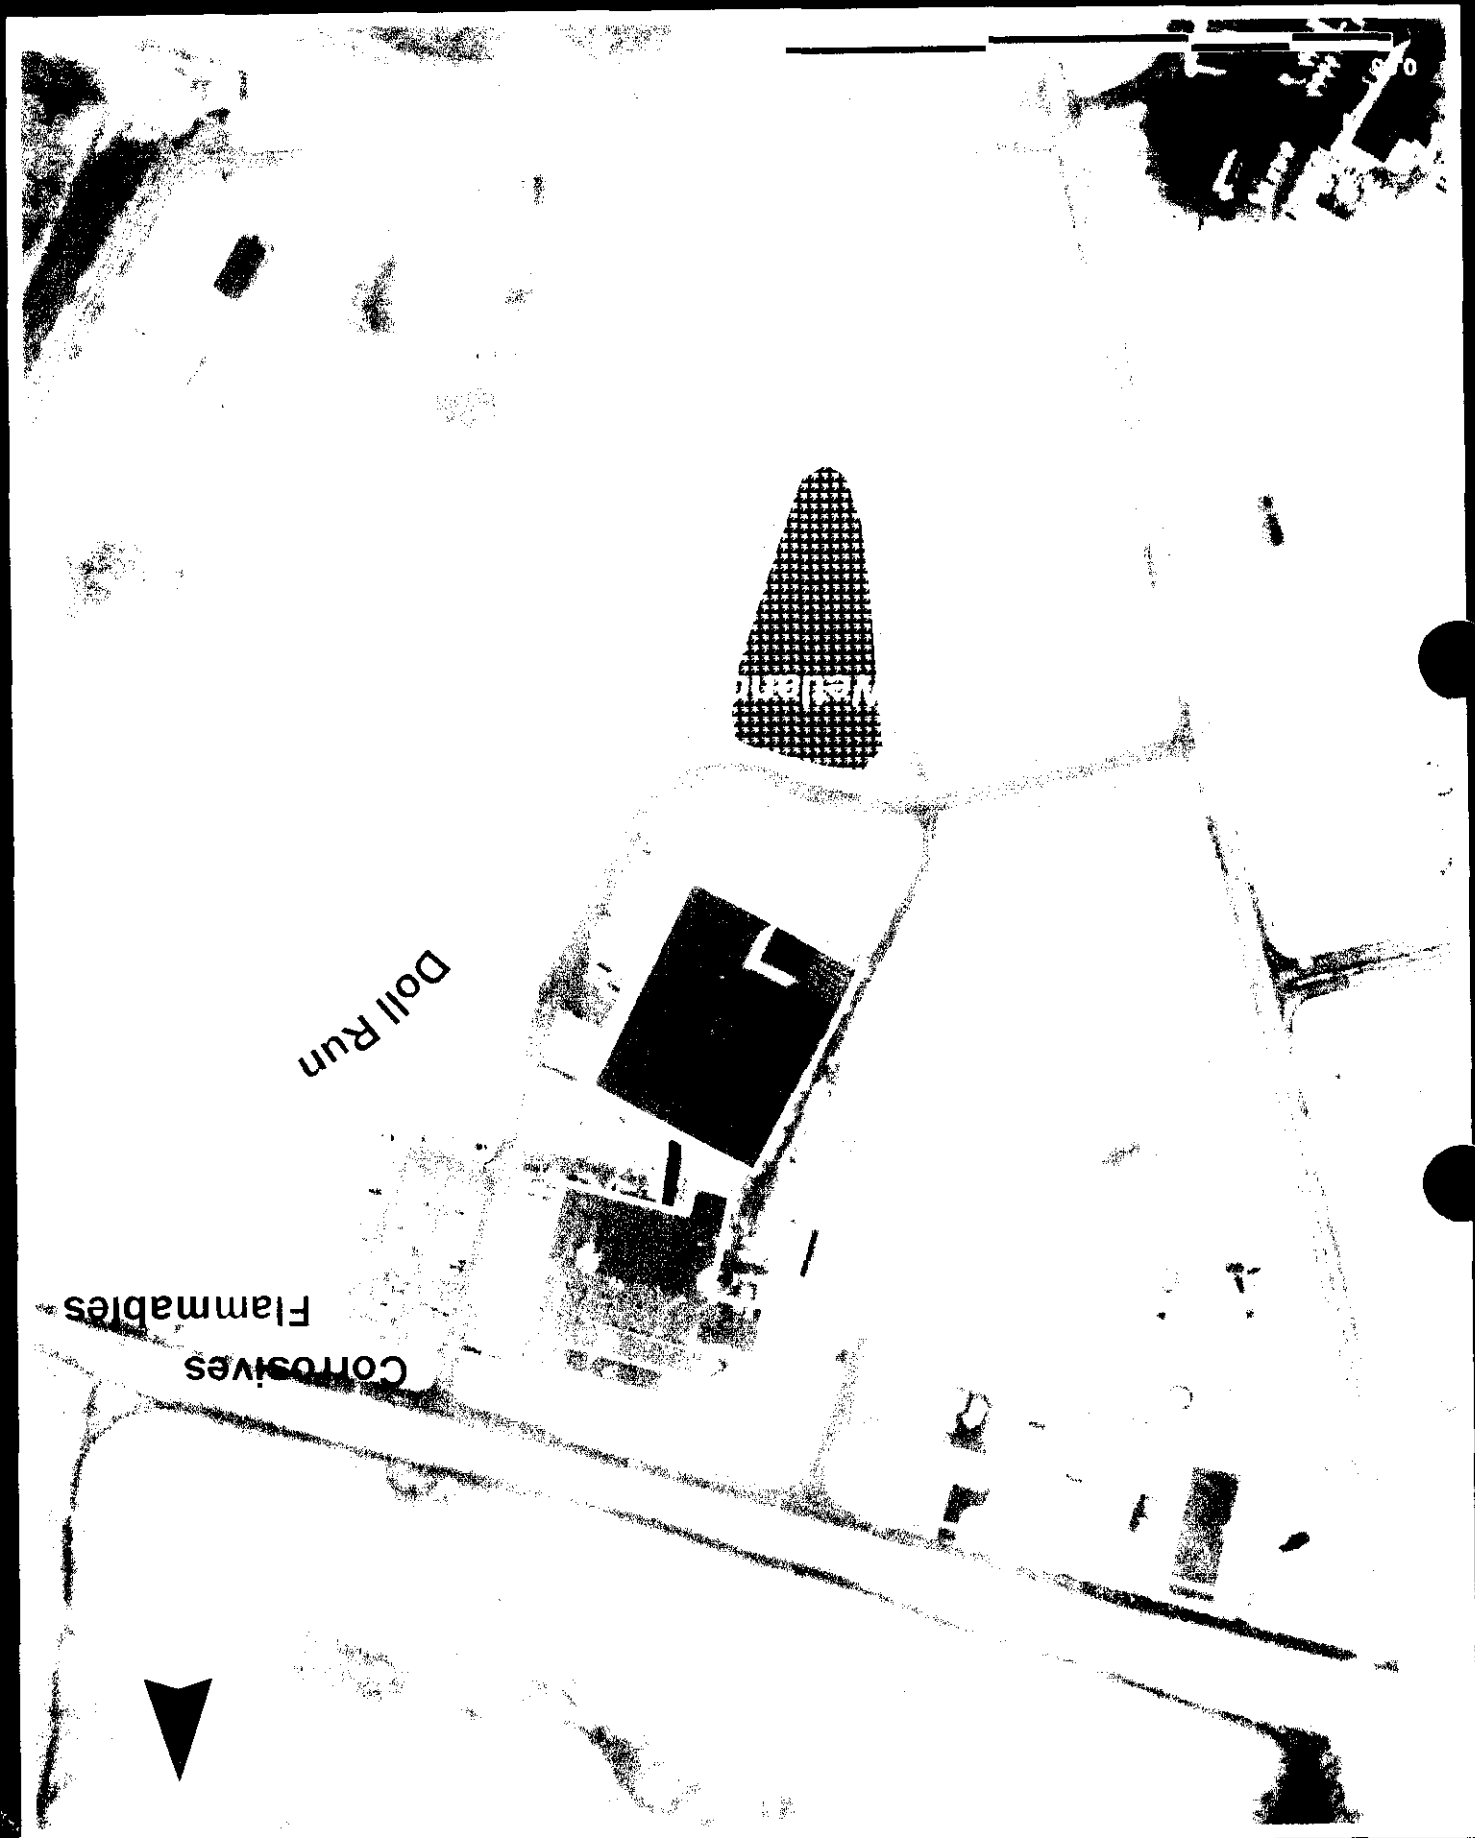
Figure 4: 1997 Aerial Photograph of the Arlon Property

which houses both divisions (Figure 4). Neither the property nor the facility are enclosed by fencing.
